Final Report

Evaluation and Report on the Insurability of Attached and Free Standing Structures

L.A. Twisdale, J. Sciaudone, P.J. Vickery, J. Chen, D. Wadhera Applied Research Associates, Inc. 8540 Colonnade Center Drive, Suite 307 Raleigh, NC 27615 Contact: Dr. L. Twisdale (919) 582-3336

ARA Project: 17819

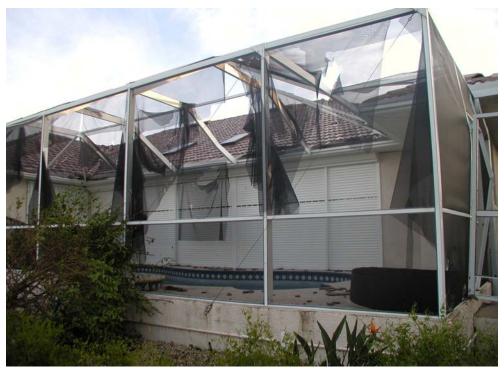
will be in compression, and will also experiencing biaxial lateral loads, and likely torsional loads. The combination of compressive, biaxial bending, and torsion will reduce the buckling capacity of the aluminum member.⁸ Figure 4-1 presents an example frame for a screen enclosure showing example forces acting on a roof member for oblique winds. The buckling of one member totally changes the load path and can lead to overloading and failure of other member failures, coupled with permanent racking and/or collapse of the frame.

Figure 4-2. Example of a Partially Failed Aluminum Screen Enclosure.

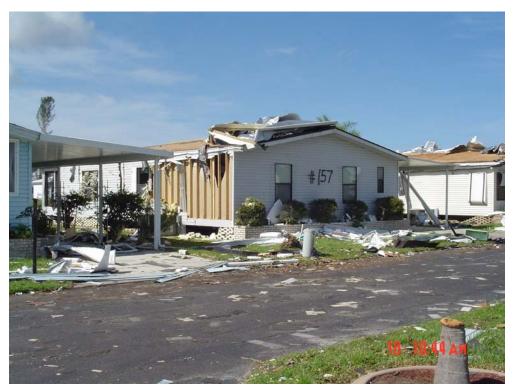
Figure 4-18. Examples of Carports on Leeward Side of Manufactured Homes Faring Relatively Well (note extensive structure damage on windward side).

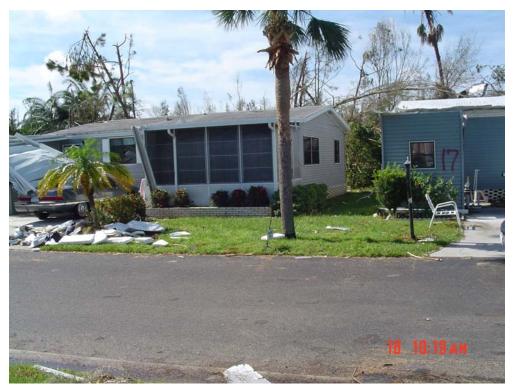
Figure 4-19. Example of Solid-Walled Patio Enclosure that Fared Well (note complete collapse of adjoining carport).
