Final Report

Evaluation and Report on the Insurability of Attached and Free Standing Structures

L.A. Twisdale, J. Sciaudone, P.J. Vickery, J. Chen, D. Wadhera Applied Research Associates, Inc. 8540 Colonnade Center Drive, Suite 307 Raleigh, NC 27615 Contact: Dr. L. Twisdale (919) 582-3336

ARA Project: 17819

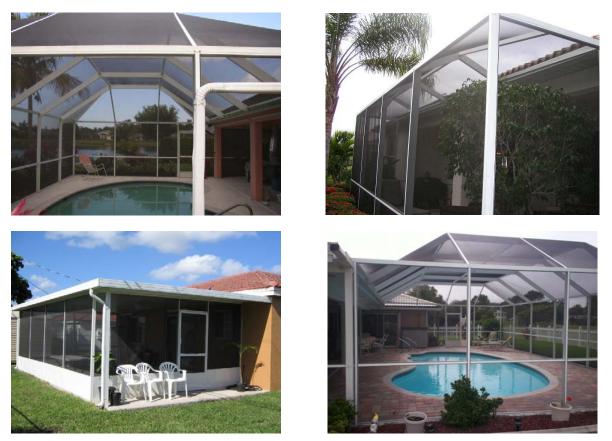
Figure 2-4. Examples of Pool/Patio Enclosures Observed During the Survey.

Pool/Patio Enclosures. Pool/patio enclosures are generally framed in aluminum and are enclosed with screening material. Figure 2-4 shows examples of typical pool/patio enclosures observed during the survey process.

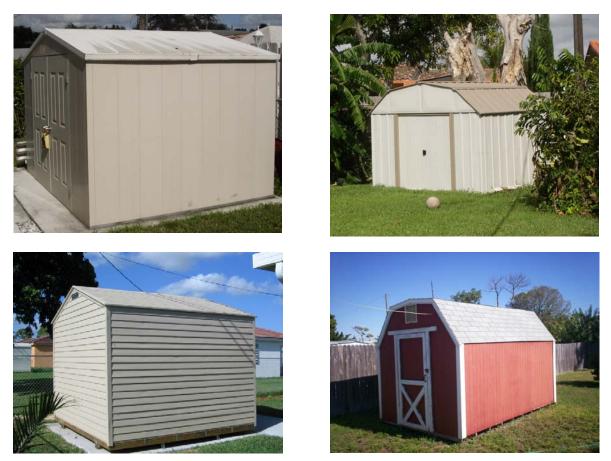
Figure 2-5. Examples of Detached Storage Sheds Observed in the Survey.

Storage Sheds. Storage sheds are commonly found detached from site-built homes. Figure 2-5 shows several examples of detached storage sheds as seen as part of the survey.

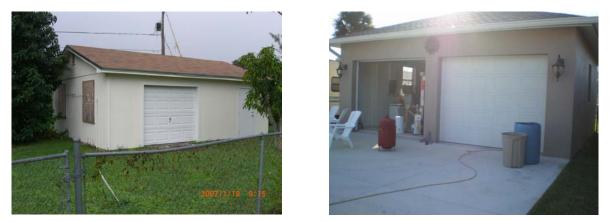
Figure 2-6. Examples of Detached Garages Observed in the Survey.

Garages. Figure 2-6 shows two examples of detached garages documented by the survey.

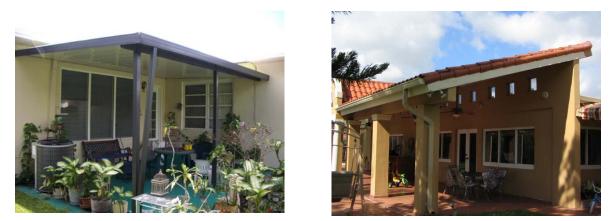
Figure 2-7. Examples of Open Structures Observed in the Survey.

Open Structures. Open structures resemble carports in that they are just roofs supported over an open area like a patio, walkway, or breezeway. Two examples of open structures documented during the survey can be seen in Figure 2-7. Open structures form a special class of structures in terms of design requirements.

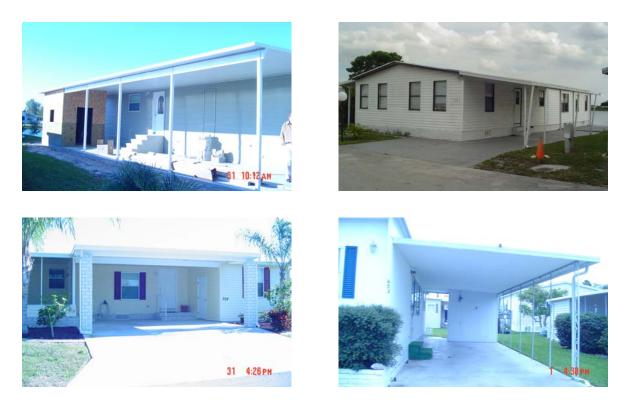
Figure 2-12. Examples of Typical Carports Found Attached to Manufactured Housing.

Carports. Carports are simple structures with 2 or more sides completely open and are generally found attached to the side or front of manufactured housing and are generally large enough to shelter one or two automobiles. Carports are generally covered with metal roofs that are attached to the fascia or wall of the host manufactured home along one side and are supported by a series of aluminum columns on the opposite side. Figure 2-12 contains four examples of typical arrangements of carports on manufactured homes.

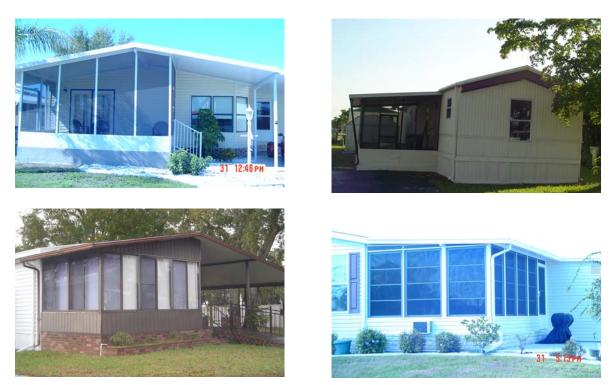
Figure 2-13. Examples of Typical Patio Enclosures Found Attached to Manufactured Housing.

Patio Enclosures. Patio enclosures are also known by other names like lanais, screened rooms, and glass enclosures. In general, patio enclosures attached to manufactured homes are founded on concrete (either on grade, or elevated via stem wall), framed with structural aluminum, and enclosed with a metal roof and either screen, glass, vinyl, or acrylic walls. Figure 2-13 shows several examples of patio enclosures observed during the survey.

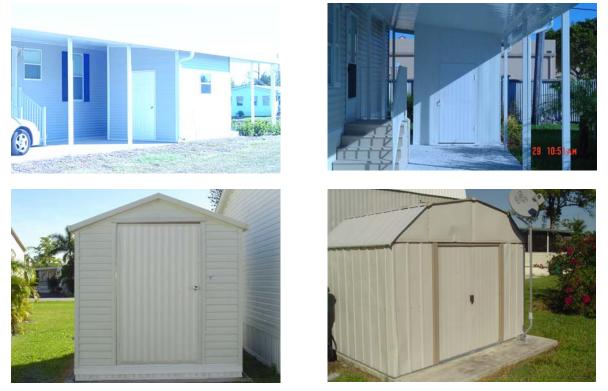
Figure 2-14. Examples of Typical Attached (upper photos) and Detached (lower photos) Observed During the Survey.

Storage Sheds. Storage sheds are commonly found both attached and detached to manufactured homes across the state. The newer parks surveyed all required that storage sheds be attached to the manufactured homes within the park. Both attached and detached storage sheds were observed in the older parks surveyed. Figure 2-14 shows examples of both attached and detached storage sheds observed during the survey process.

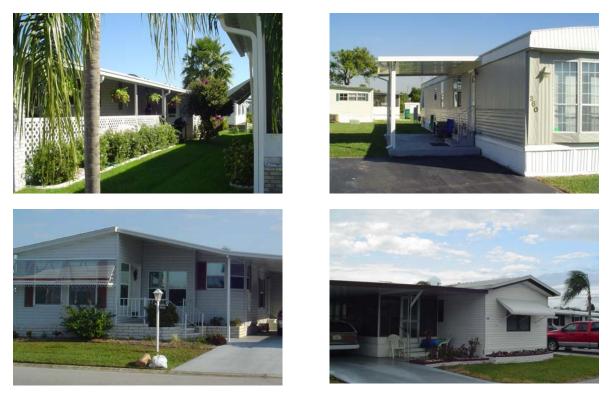
Figure 2-15. Examples of Typical Open Structures Found Attached to Manufactured Housing.

Open Structures. Open structures are constructed in a similar manner to carports, however, their purpose is not to protect vehicles, but rather to cover a walkway, porch, or breezeway. Examples of open structures observed attached to manufactured homes can be found in Figure 2-15.

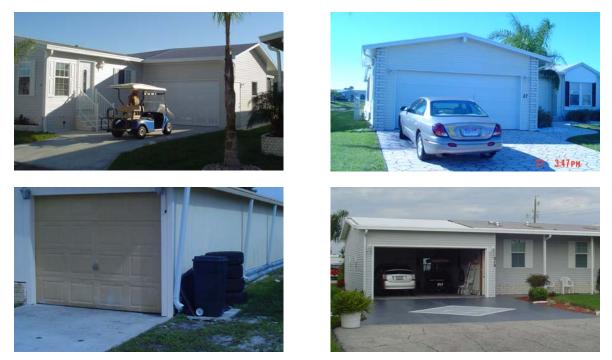
Figure 2-16. Examples of Typical Garages Observed Attached to Manufactured Homes.

Garages. Several manufactured homes surveyed had attached garages. On some older homes, these garages were basically carports that had been enclosed with solid walls and/or siding. Garages on newer homes tended to be originally designed as garages. Figure 2-16 shows examples of garages observed during the survey.

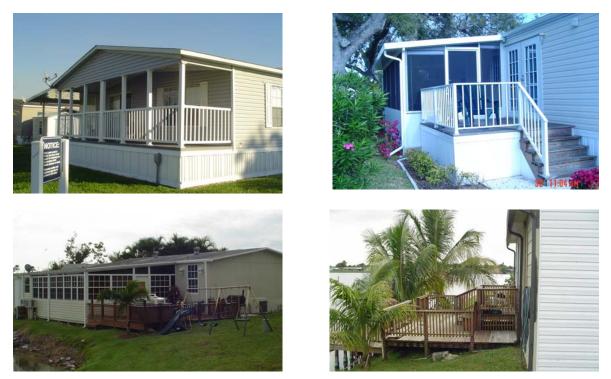
Figure 2-17. Examples of Typical Decks Observed Attached to Manufactured Homes.

Decks. Two different styles of decks were observed during the survey. One type is a built-in style where the deck is founded on the chassis of the home and is covered by the roof of the home. This type is really built integrally with the home and is not attached after installation of the home. The second style is the more traditional site-built wood deck founded on embedded columns and built after the home is in place. Figure 2-17 shows examples of decks observed during the survey.

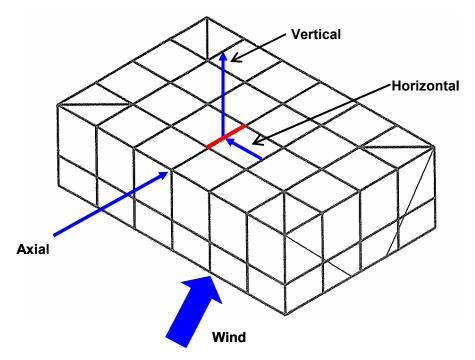
will be in compression, and will also experiencing biaxial lateral loads, and likely torsional loads. The combination of compressive, biaxial bending, and torsion will reduce the buckling capacity of the aluminum member.⁸ Figure 4-1 presents an example frame for a screen enclosure showing example forces acting on a roof member for oblique winds. The buckling of one member totally changes the load path and can lead to overloading and failure of other member failures, coupled with permanent racking and/or collapse of the frame.

Figure 4-1. Forces Acting on Individual Member for Oblique Winds.

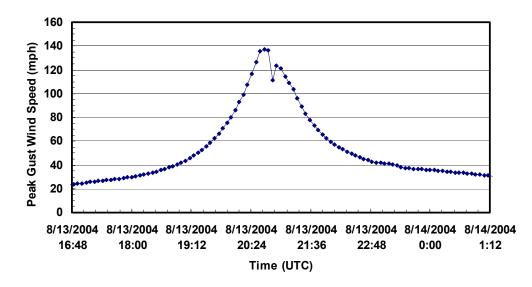
Figure 4-3. Modeled Peak Gust Wind Speeds for Hurricane Charley at the Location of the Surveyed Screen Enclosures.

Table 4-2 presents the results of a survey by ARA engineers following Hurricane Charley in the Punta Gorda area. A total number of 67 houses were surveyed in several neighborhoods. The survey focused on the residences, but sufficient pictures were taken to allow us to analyze the data in terms of pool/patio enclosures for this project. The maximum peak gust wind speeds (at a height of 10m in open terrain) were estimated to be about 140 mph. Figure 4-3 presents a plot of the modeled peak gust wind speeds at the locations of the homes used in the survey.

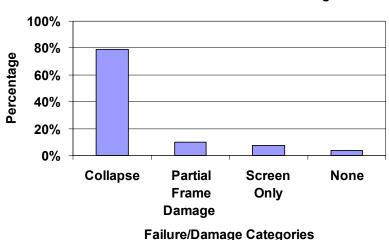
Figure 4-4. Performance of Screen Enclosures in Hurricane Charley.

Figure 4-4 indicates that 79% of the aluminum screen enclosures experienced a complete collapse. Also, as indicated in Figure 4-4, of the 47 enclosures that experienced any frame damage, 42 had a complete collapse, supporting the hypothesis that the lack of redundancy tends

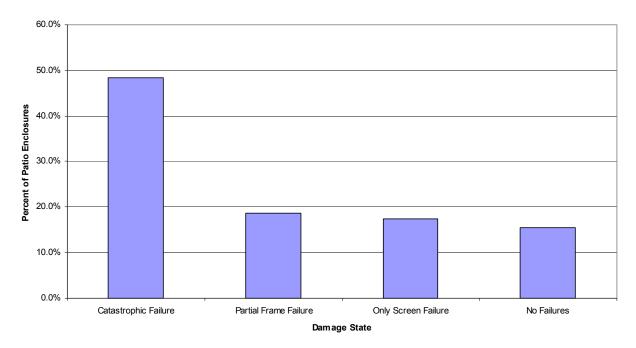
Figure 4-16 shows the distribution of patio enclosure damage observed in the damage photos into damage states of catastrophic failure, partial frame failure, only screen failure, and no failures. Figure 4-17 shows the distribution of carport damage observed in the damage photos into damage states of catastrophic failure, partial failure, and no failures.

Figure 4-16. Distribution of Manufactured Home Patio Enclosure Damage in Hurricane Charley.

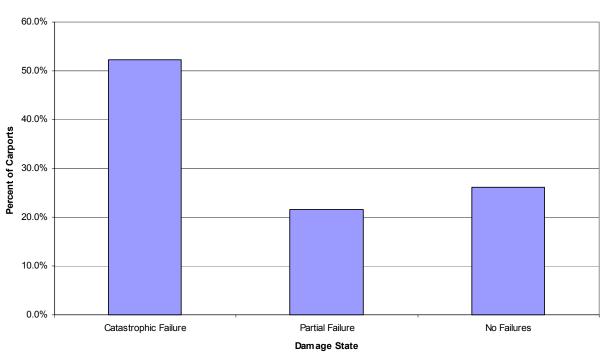
Figure 4-17. Distribution of Manufactured Home Carport Damage in Hurricane Charley.

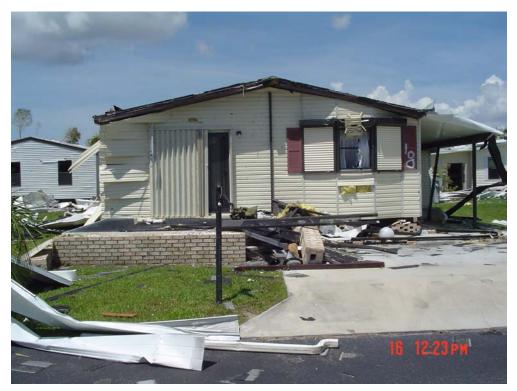
- Patio enclosures and carports located on the leeward side of the home fared much better than those on the windward side (See Figure 4-18).
- Patio enclosures with solid walls (siding and/or vinyl, acrylic, or glass windows) appeared to suffer less damage than those with screen only walls (See Figure 4-19).
- Combined attachments of patio enclosures and carports along the front of homes appeared to be more vulnerable than those attached along the side of the home (See Figure 4-20).

Figure 4-20. Example of Patio Enclosure and Carport Collapse Along Front of Home with Carport Section on Side of Home Still Standing.

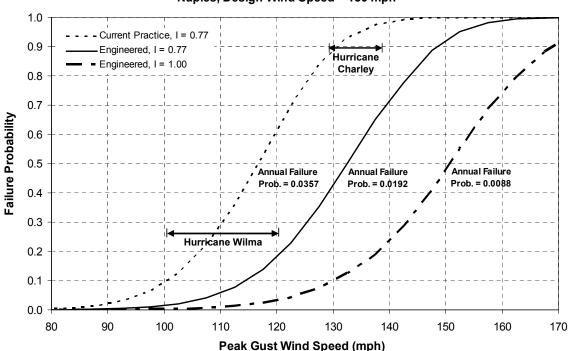
Approach. Hypothetical loss functions are developed to represent the performance of aluminum screen enclosures. The first loss function corresponds to current (as-built) practice and was developed by approximately matching: (1) the observed failure rates of aluminum screen enclosures in Hurricane Charley (~88+% at peak gust wind speeds of ~130+ mph)²; and (2) an estimated ~20%-30% for gust wind speeds in the range of 100-120 mph range, typical of Hurricane Wilma. This "as-built" loss function given in Figure 5-1 is for a design wind speed of 130 mph, an importance factor of 0.77, and existing design/construction flaws. The peak gust windspeeds in Figure 5-1 are referenced to open terrain windspeeds at 10 m height.

Figure 5-1. Hypothetical Vulnerability Functions for Aluminum Frame Enclosure in Naples.

The middle loss curve in Figure 5-1 represents our estimate of a properly engineered aluminum screen enclosure, designed to 130 mph design winds (design winds in Naples) using an importance factor of 0.77 (the current importance factor required by ASCE 7 and the FBC). Considering the importance factor, the effective design wind speed is about 115 mph for the middle curve.

Results. In the example given in Figure 5-1, the screen enclosure is located near the Naples area, and the loss functions have been integrated with a hurricane hazard model, applicable to coastal Naples, to produce estimates of the average annual failure rates for the three loss curves.

the reduction in current loss costs for an aluminum frame screen enclosure in Naples is about 25%. That is, the loss costs would be reduced by a factor of about 4 over current practice. This reduction requires research to developed improved load and design procedures and changes to the building codes for importance factors structures attached to residential structures.

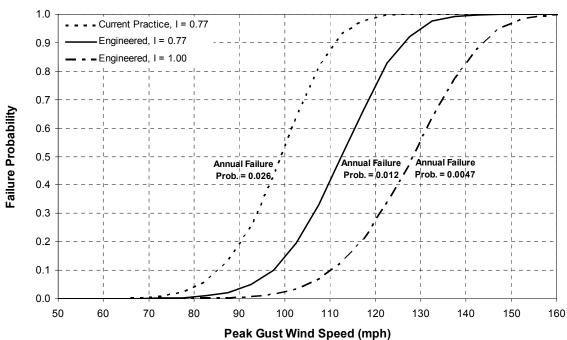
Figure 5-2 presents a similar set of results for a screen enclosure located in Orlando, where in this case, the current practice as-built loss function is developed assuming a design wind speed of 110 mph. We see that the reductions in loss cost in Table 5-2 are generally similar to Naples and show significant reductions with proper designs to the "right" loads, coupled with a change in importance factor. In Orlando, the loss cost reduction would be expected to be a factor of about 5.5.

Figure 5-2. Hypothetical Vulnerability Functions for Aluminum Frame Enclosure in Orlando.
